Property Condition Assessment Overview
138 S. Brandon Rd.
1.2021

FACILITY CONDITION ASSESSMENT

Subject: FACILITY CONDITION ASSESSMENT
Fallbrook Regional Health District Office Building
138 South Brandon Road, Fallbrook, California 92028
AEI Project No. 429357

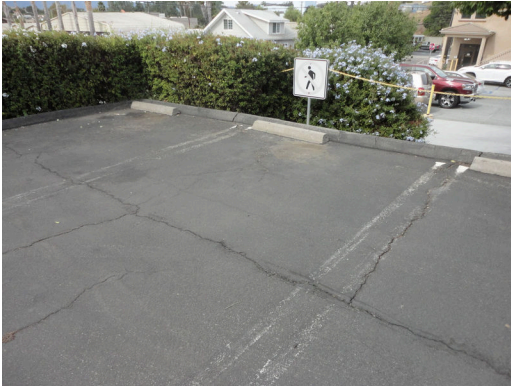
Broken asphalt curb

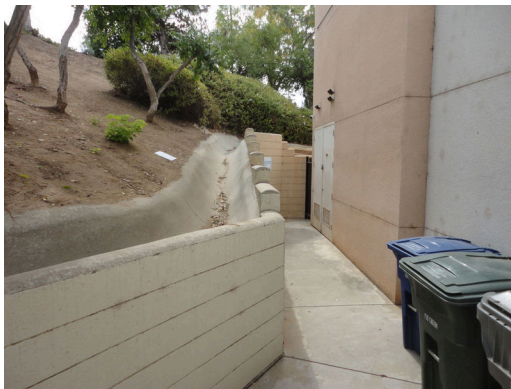
Area of water intrusion into elevator pit

As a stop gap measure, AEI recommends installation of a sump pump in the elevator pit to alleviate storm water buildup. An allowance for this work is included in the Tables.

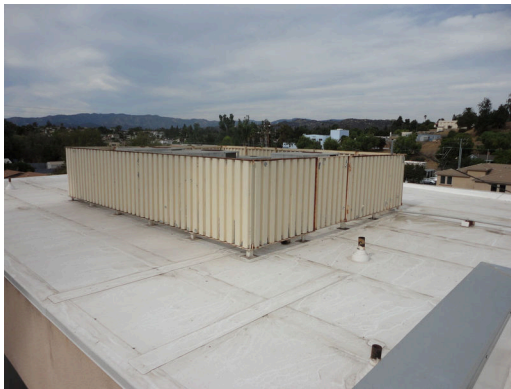
AEI observed debris around the roof drain. The field of the roof should be evaluated semi-annually at a minimum to clean debris and verify roof condition. Blocking drains can lead to ponding, and premature roof deterioration.

Overall view of roof

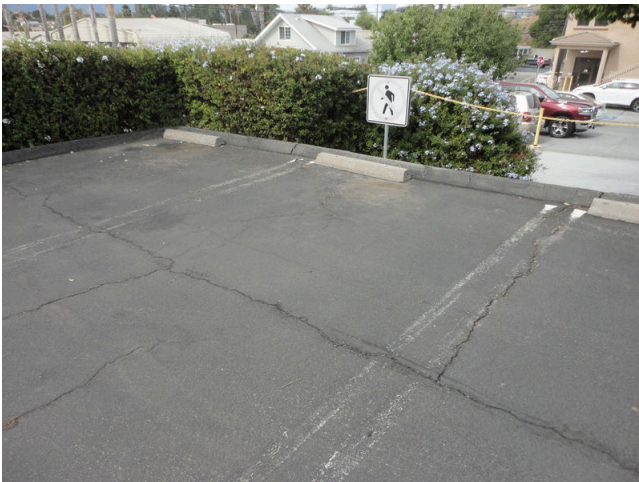
7. Cracks and faded striping

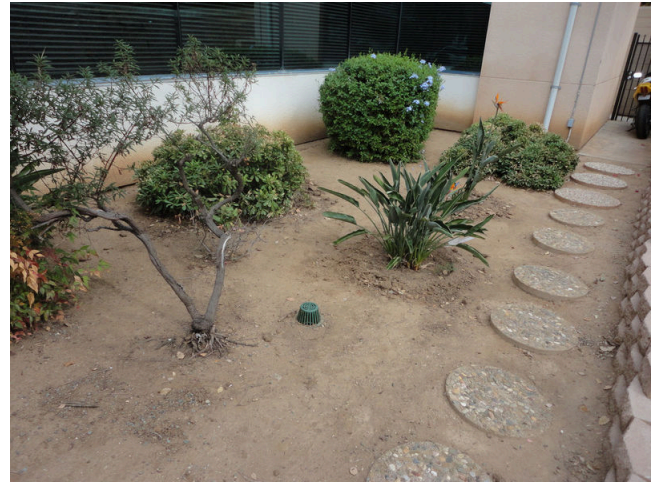
14. Bare area in landscaping

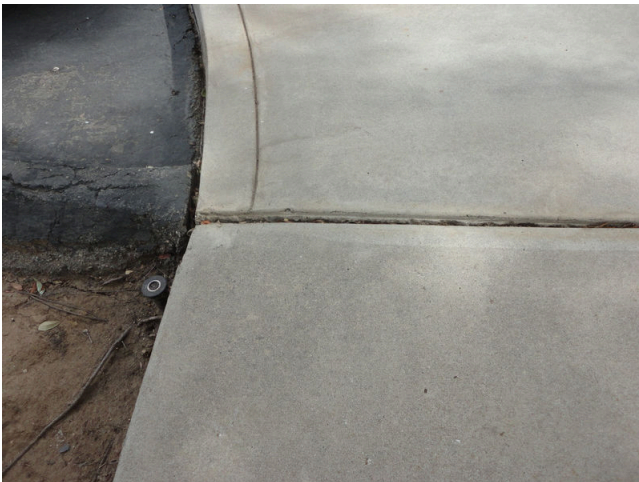
46. Broken asphalt curb

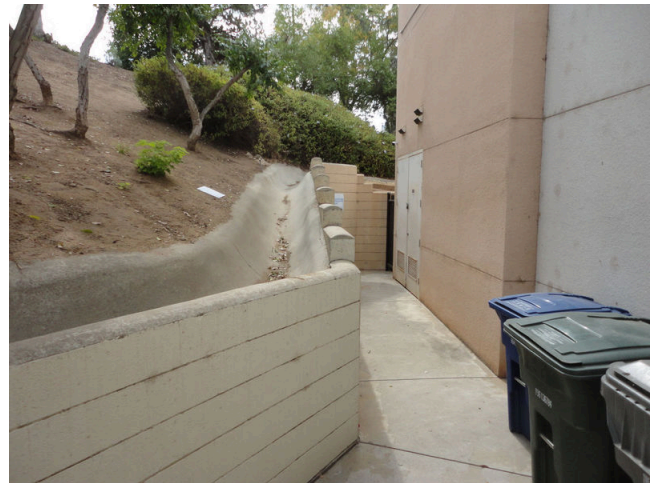
50. Area of water intrusion into elevator pit
