AEI Consultants

FACILITY CONDITION ASSESSMENT

Fallbrook Regional Health District Office Building
138 South Brandon Road
Fallbrook, California 92028

AEI Project No. 429357

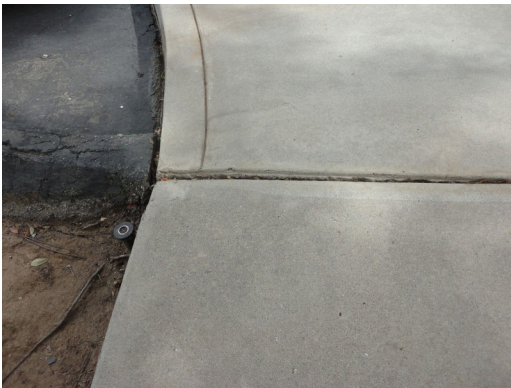
Concrete steps at east property line

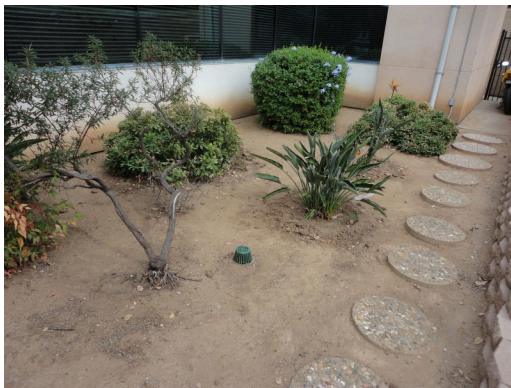
Bare area in landscaping

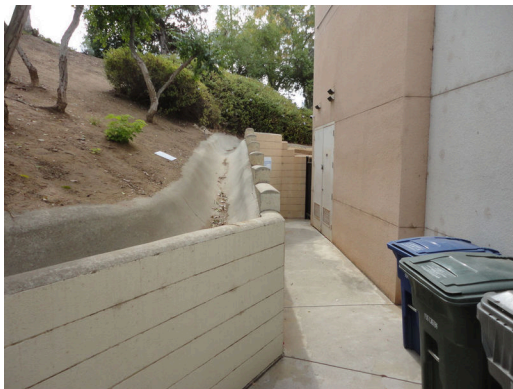
Area of water intrusion into elevator pit

It was reported by the site contact that the elevator pit has had periodic water intrusion and the elevator inspection report dated 5/15/2020 stated that there was two inches of water at the bottom of the pit. An inspection by a waterproofing contractor is recommended as an immediate repair.

As a stop gap measure, AEI recommends installation of a sump pump in the elevator pit to alleviate storm water buildup. An allowance for this work is included in the Tables.

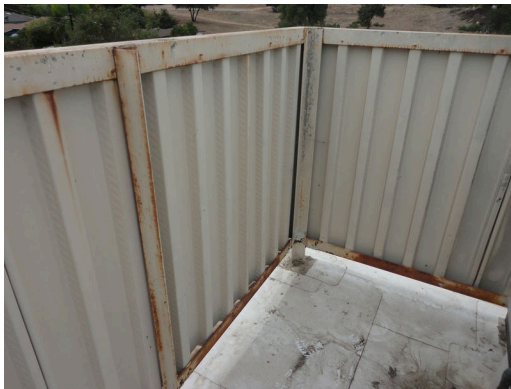
AEI observed corrosion on the metal HVAC screening at the roof. Corrosion, if left unchecked, can lead to premature failure of the system. AEI recommends the panels be prepped, the sealed with a corrosion inhibiting coating. These panels should be painted during the exterior wall painting discussed above and costs are included with that allowance.

Rust on metal screen on roof

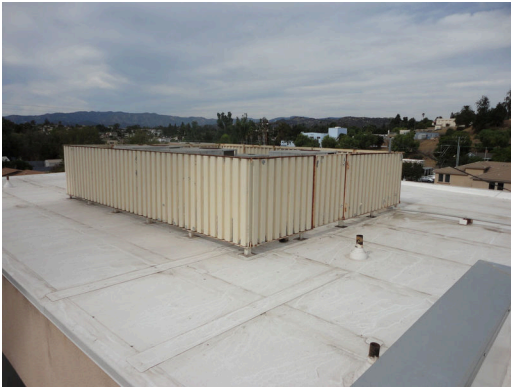
AEI observed debris around the roof drain. The field of the roof should be evaluated semi-annually at a minimum to clean debris and verify roof condition. Blocking drains can lead to ponding, and premature roof deterioration.

Overall view of roof

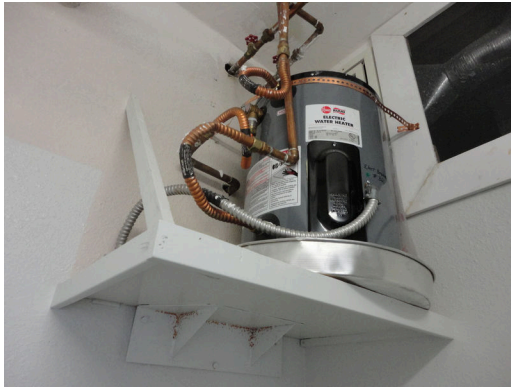
The water heater is in good condition and was noted to have proper seismic strapping. Water heaters of this type typically have an useful life of 10 to 12 years. Replacement of the water heater is anticipated during the term and an opinion of cost is included in the Capital Reserve Schedule.

Water heater

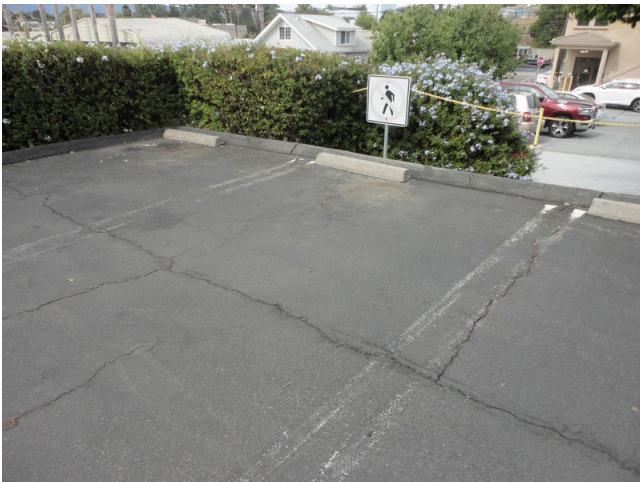
7. Cracks and faded striping

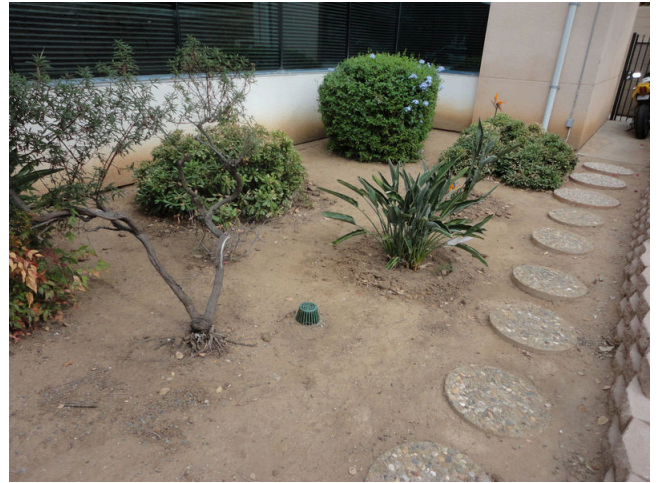
14. Bare area in landscaping

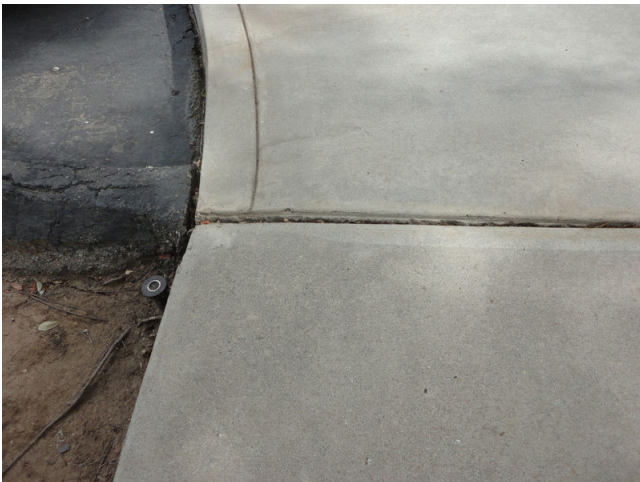
46. Broken asphalt curb
