Property Condition Assessment Overview
138 S. Brandon Rd.
1.2021

FACILITY CONDITION ASSESSMENT

Subject: FACILITY CONDITION ASSESSMENT
Fallbrook Regional Health District Office Building
138 South Brandon Road, Fallbrook, California 92028
AEI Project No. 429357

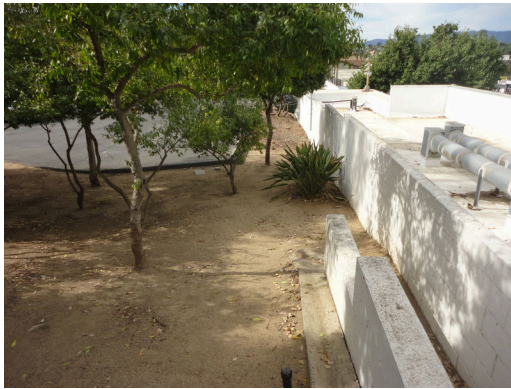
Retaining wall along north boundary

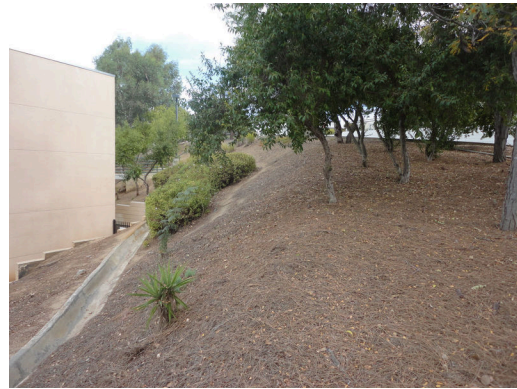
Drainage channel for slope

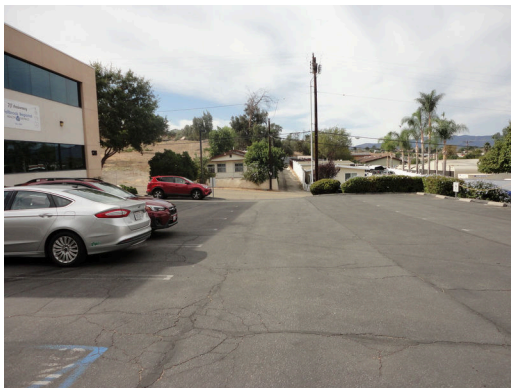
The asphalt pavement systems are in fair condition. AEI noted significant longitudinal cracking through the pavement system. Areas of alligating were noted, indicating potential sub-base failure. Based on the observed conditions, AEI recommends budgeting for milling and overlay of the asphalt pavement system early during the term. An opinion of cost for this work is included in the Tables.

Asphalt paved parking lot

Seal coating helps to protect the asphalt surface from agents of deterioration for pavements include traffic abrasion, vehicle weight, weathering, sunlight, and ultraviolet light. After the asphalt is seal coated, the parking spaces should be re-striped. AEI recommends seal coating and striping be performed every 5 years to maintain the pavement systems. An allowance for this work is included in the Tables.

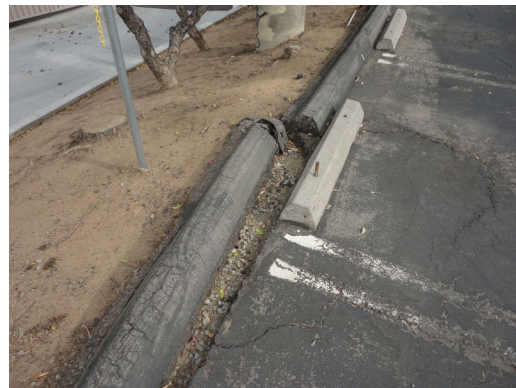
AEI noted one area of damaged asphalt curbing. The soils below the pavement appear to have eroded, allowing the pavement and curbing at that area to fail. Rebuilding and replacement are recommended. An allowance for this work is included in the Tables.

Broken asphalt curb

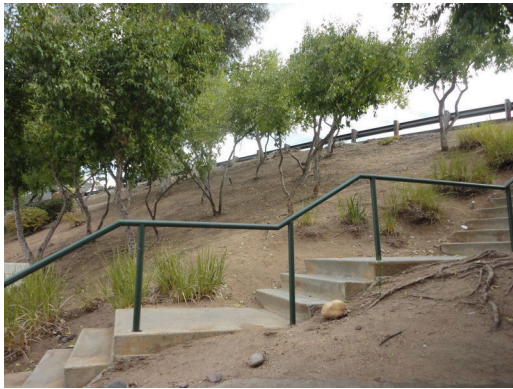
The exterior concrete steps in were noted to be in good condition. Routine maintenance is anticipated during the projection period covered by this report.

Concrete steps to east property line

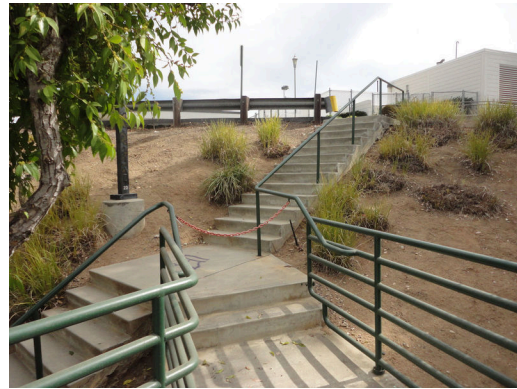
Concrete steps at east property line

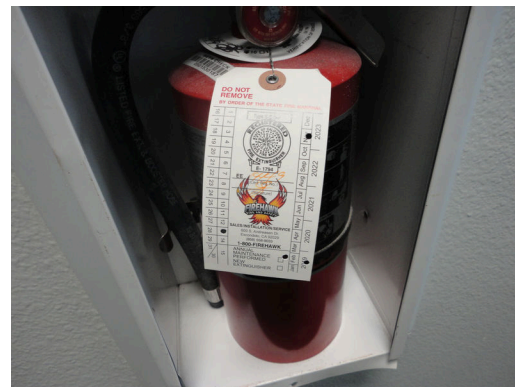
Current tag on fire extinguisher

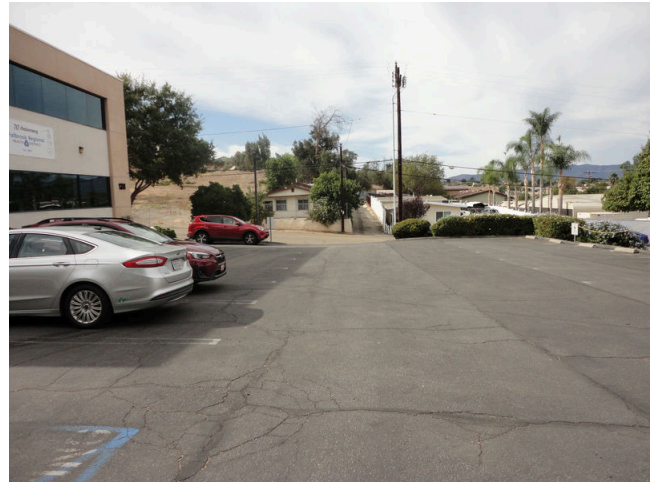
6. Asphalt paved parking lot

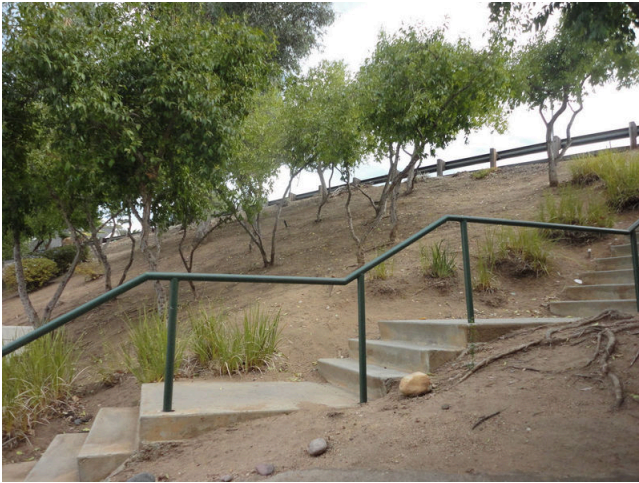
9. Concrete steps to east property line

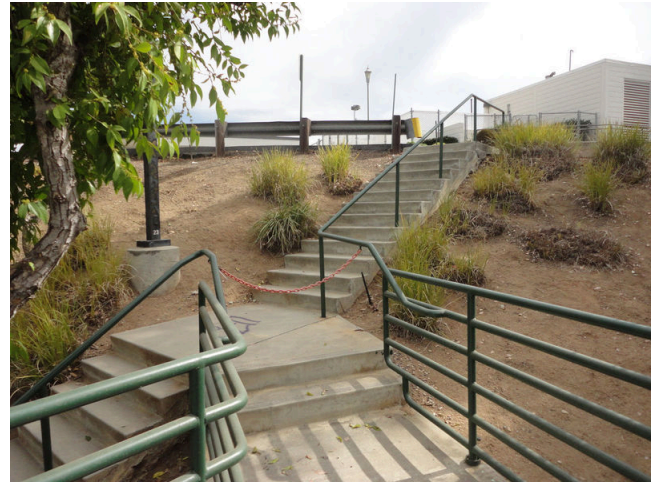
10. Concrete steps at east property line

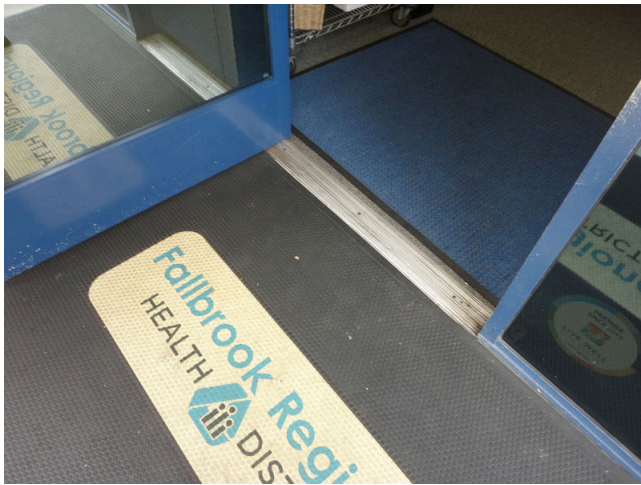
17. ADA compliant threshold

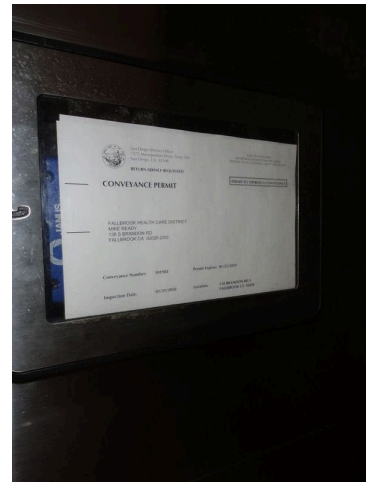
28. Expired elevator tag

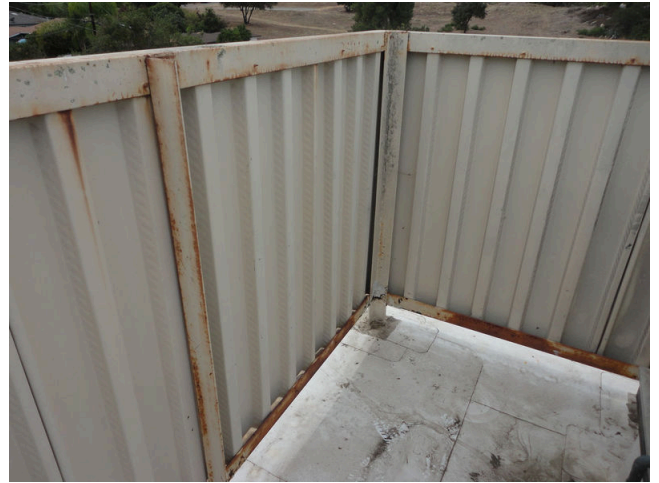
42. Rust on metal screen on roof
