AEI Consultants

FACILITY CONDITION ASSESSMENT

Fallbrook Regional Health District Office Building
138 South Brandon Road
Fallbrook, California 92028

AEI Project No. 429357

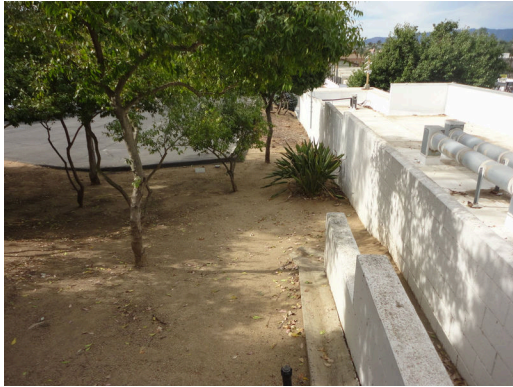
Retaining wall along north boundary

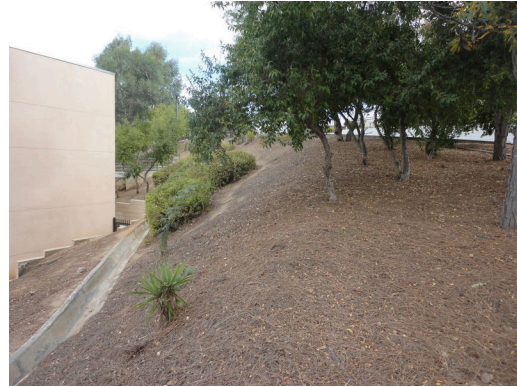
Drainage channel for slope

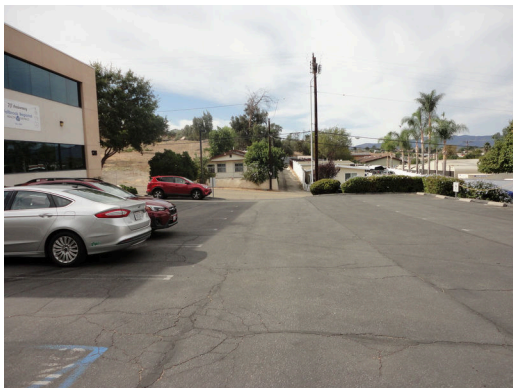
The asphalt pavement systems are in fair condition. AEI noted significant longitudinal cracking through the pavement system. Areas of alligating were noted, indicating potential sub-base failure. Based on the observed conditions, AEI recommends budgeting for milling and overlay of the asphalt pavement system early during the term. An opinion of cost for this work is included in the Tables.

Asphalt paved parking lot

Seal coating helps to protect the asphalt surface from agents of deterioration for pavements include traffic abrasion, vehicle weight, weathering, sunlight, and ultraviolet light. After the asphalt is seal coated, the parking spaces should be re-striped. AEI recommends seal coating and striping be performed every 5 years to maintain the pavement systems. An allowance for this work is included in the Tables.

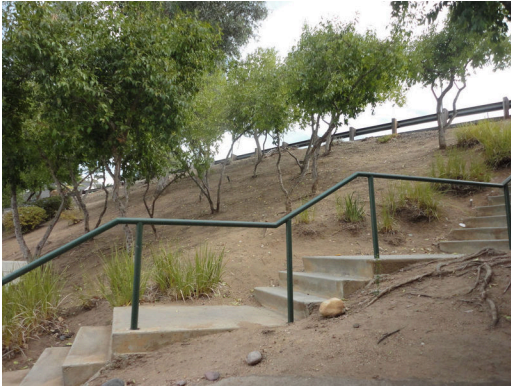
The exterior concrete steps in were noted to be in good condition. Routine maintenance is anticipated during the projection period covered by this report.

Concrete steps to east property line

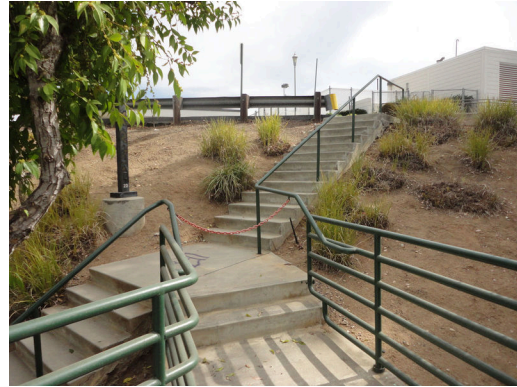
Concrete steps at east property line

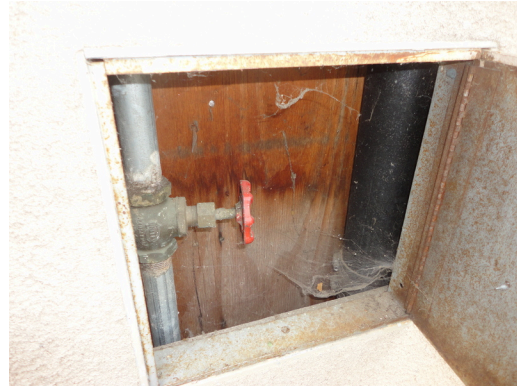
The galvanized piping at the Property is over 26 years old, and typically has a 35 to 40 year useful life. No leaks in the supply lines have been reported. Given the age of the system and the noted areas of concern, AEI recommends management be prepared to replace the galvanized supply line during term. An opinion of cost has been included in the Cost Tables for replacement.

Water supply line

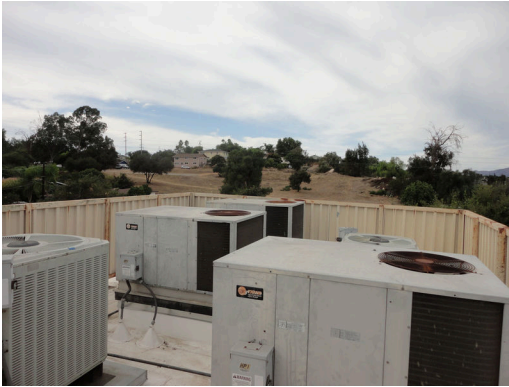
HVAC units on roof

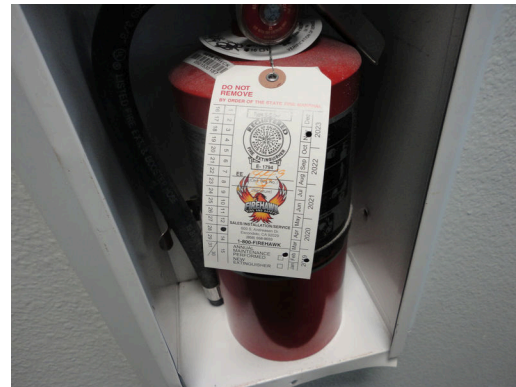
Current tag on fire extinguisher

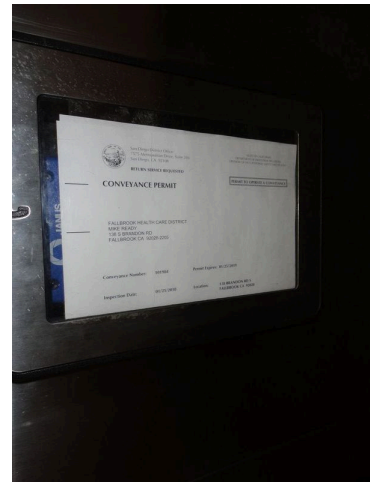
28. Expired elevator tag
