Property Condition Assessment Overview
138 S. Brandon Rd.
1.2021

FACILITY CONDITION ASSESSMENT

Subject: FACILITY CONDITION ASSESSMENT
Fallbrook Regional Health District Office Building
138 South Brandon Road, Fallbrook, California 92028
AEI Project No. 429357

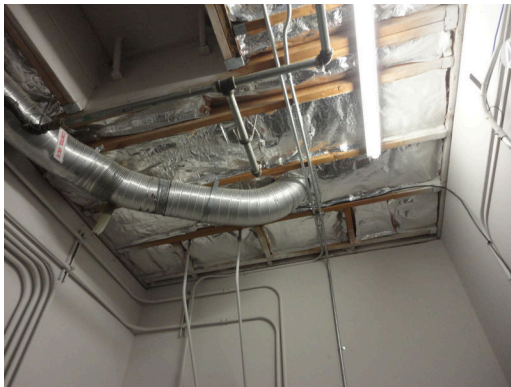
The structural system appears to be providing effective support for the building envelope and interior floors. No unusual problems or concerns were reported or observed pertaining to the superstructure.

Building structure

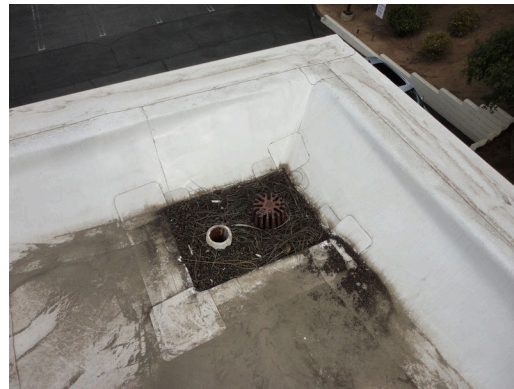
Roof drain

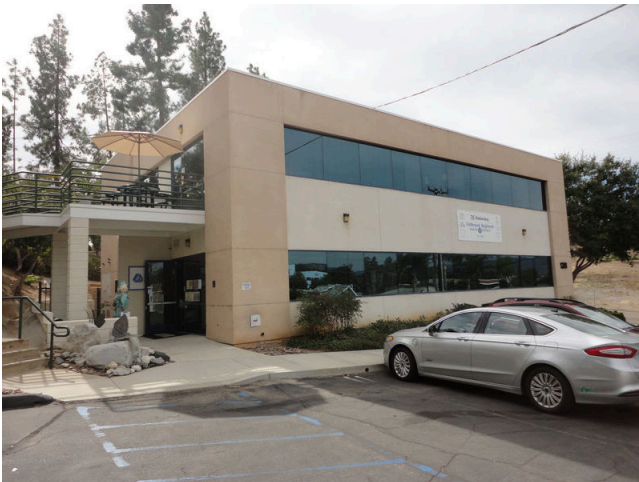
3. North elevation

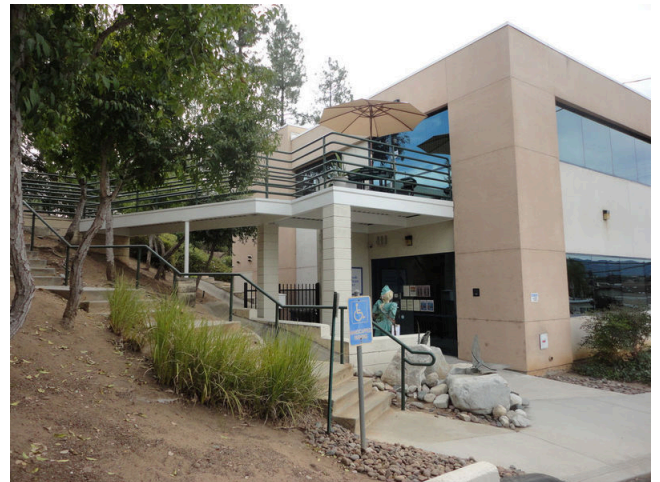
4. East elevation

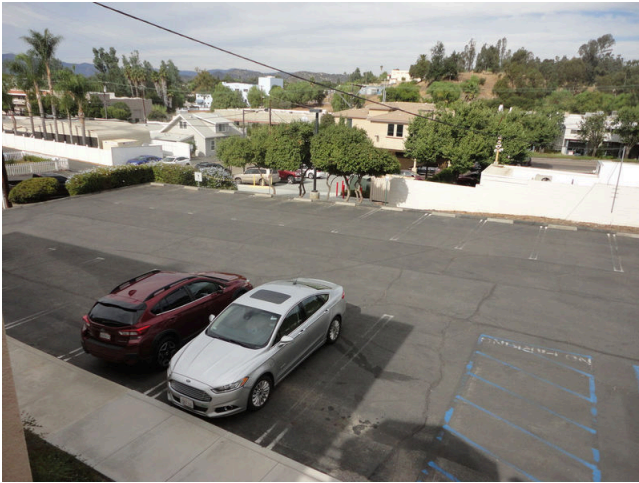
5. View of parking lot

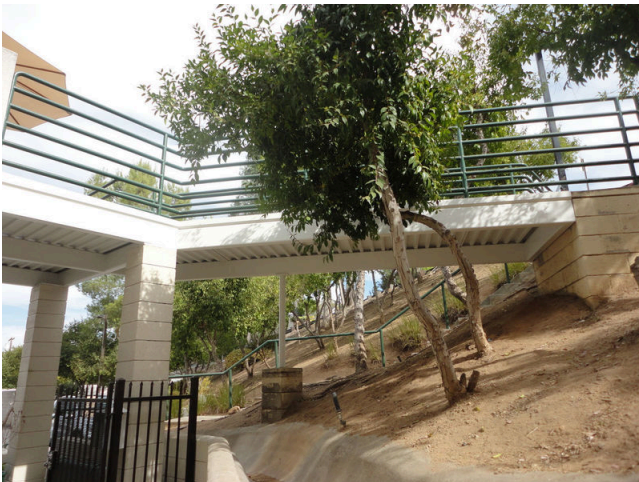
11. Exterior walkway to east property line

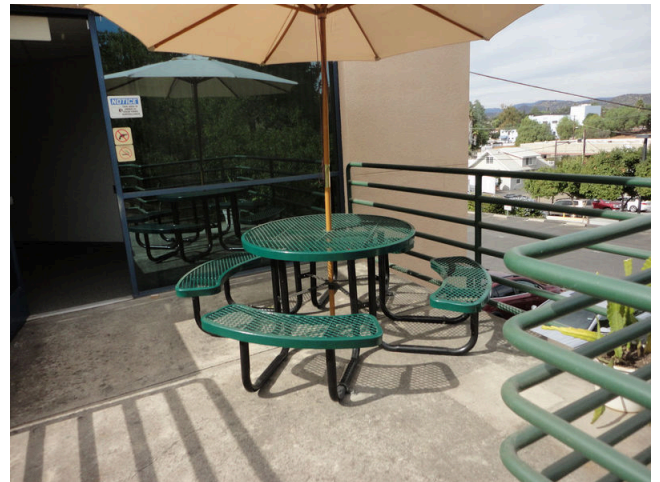
12. Picnic table with benches

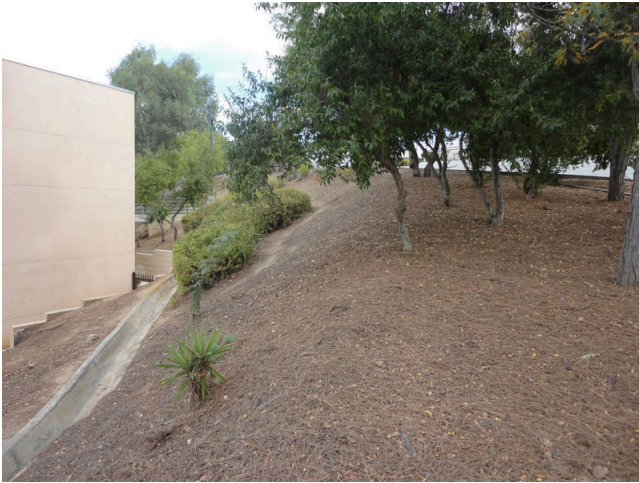
13. Drainage channel for slope

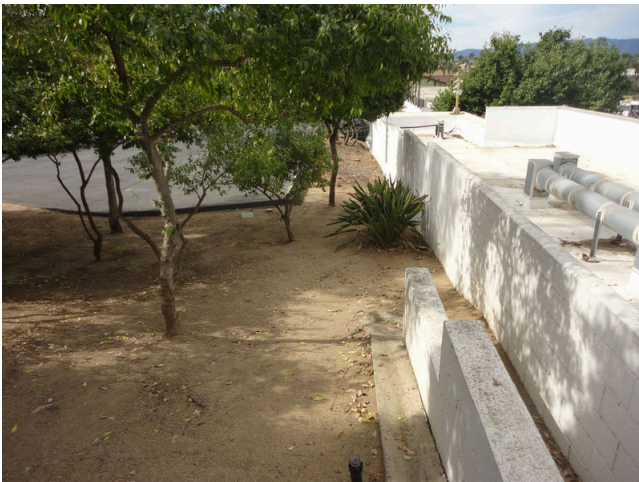
15. Retaining wall along north boundary

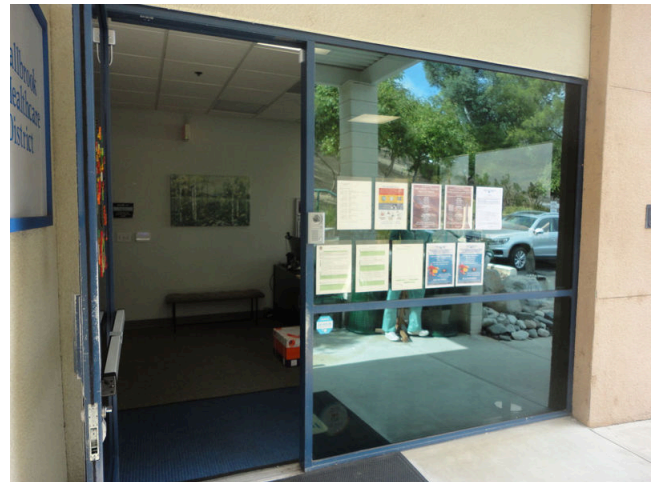
16. Main entrance
