AEI Consultants

FACILITY CONDITION ASSESSMENT

Fallbrook Regional Health District Office Building
138 South Brandon Road
Fallbrook, California 92028

AEI Project No. 429357

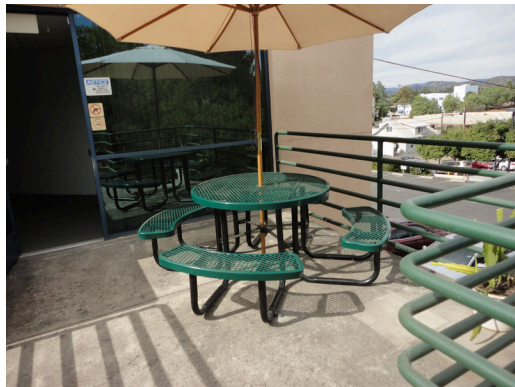
Routine maintenance is expected to be adequate to maintain the site amenities in good condition during the projection period covered by this report.

Picnic table with benches

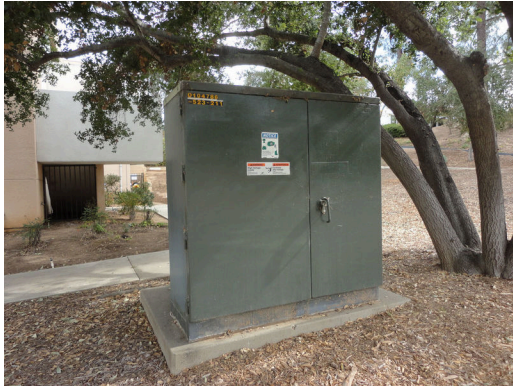
Electrical transformer

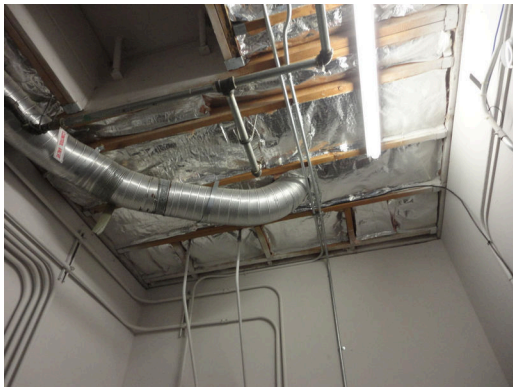
The structural system appears to be providing effective support for the building envelope and interior floors. No unusual problems or concerns were reported or observed pertaining to the superstructure.

Building structure

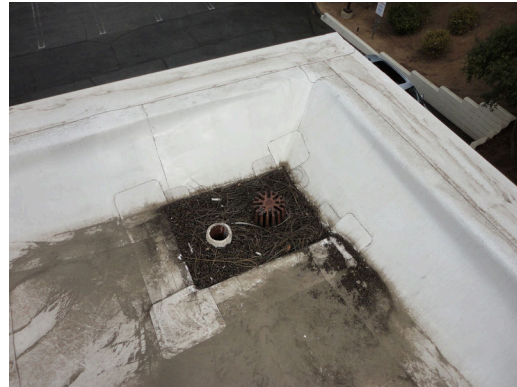
Roof drain

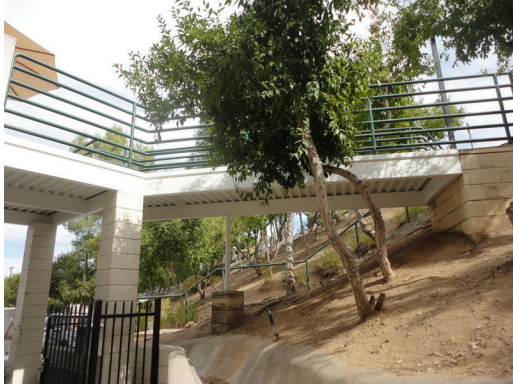
Exterior walkway to east property line

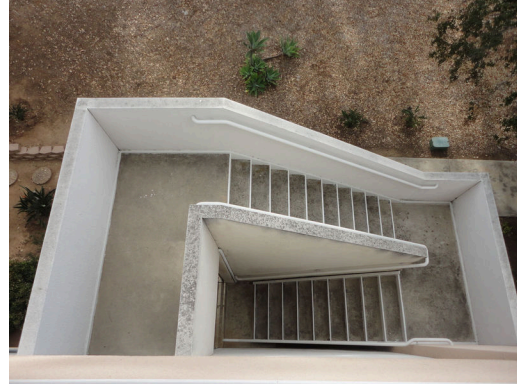
Exterior stairs

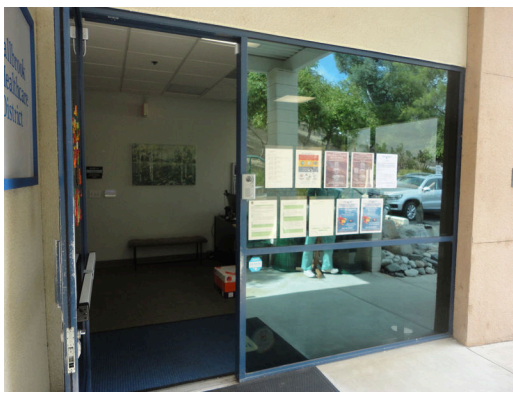
Main entrance

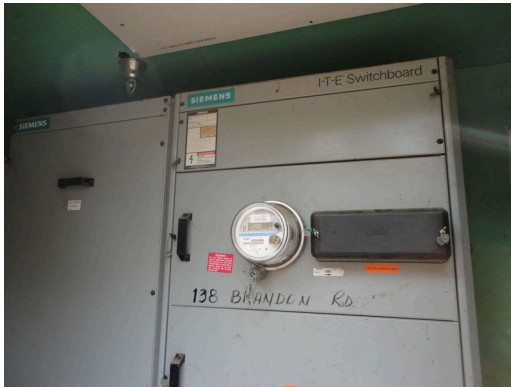
Electrical switchgear

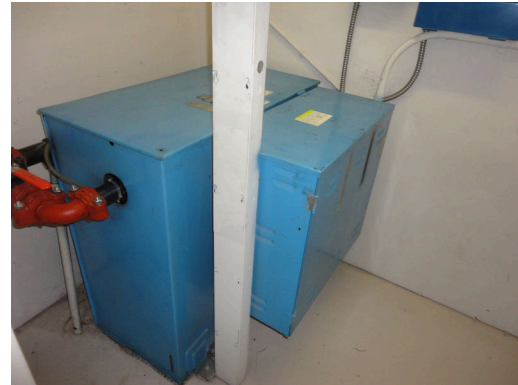
Elevator equipment

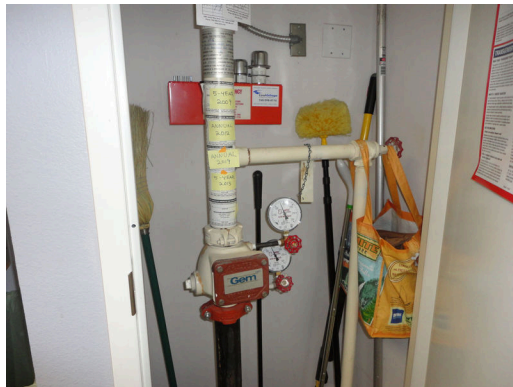
Routine maintenance is expected to be adequate to maintain the fire safety systems in good condition during the projection period covered by this report.

Fire sprinkler

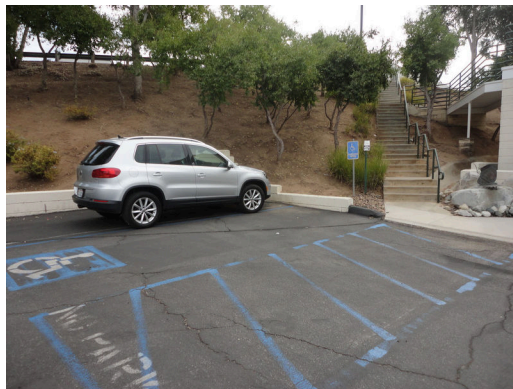
ADA parking space

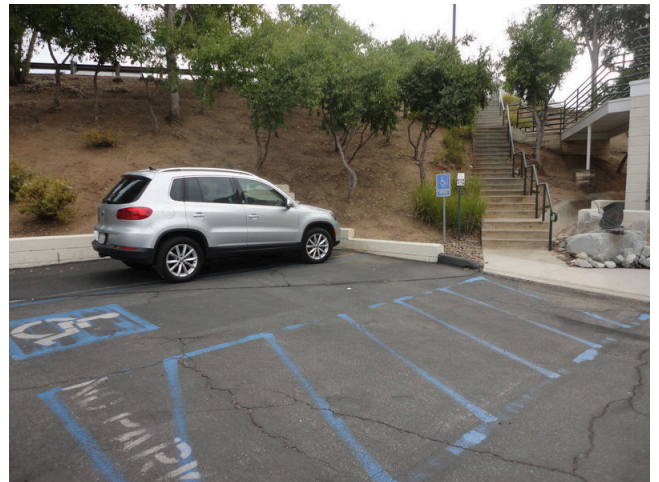
8. ADA parking space

Cost Recommendation	EUL	EFF AGE	RUL	Year	Cost
Include van stall signage (vertical only)	-	-	-	Immediate	\$50
Total					\$50
